BUFFALO RIVER REMEDIAL ACTION PLAN

2005 STATUS REPORT

**PREPARED BY:
BUFFALO NIAGARA RIVERKEEPER
DRAFT COPY, OCTOBER 2005**

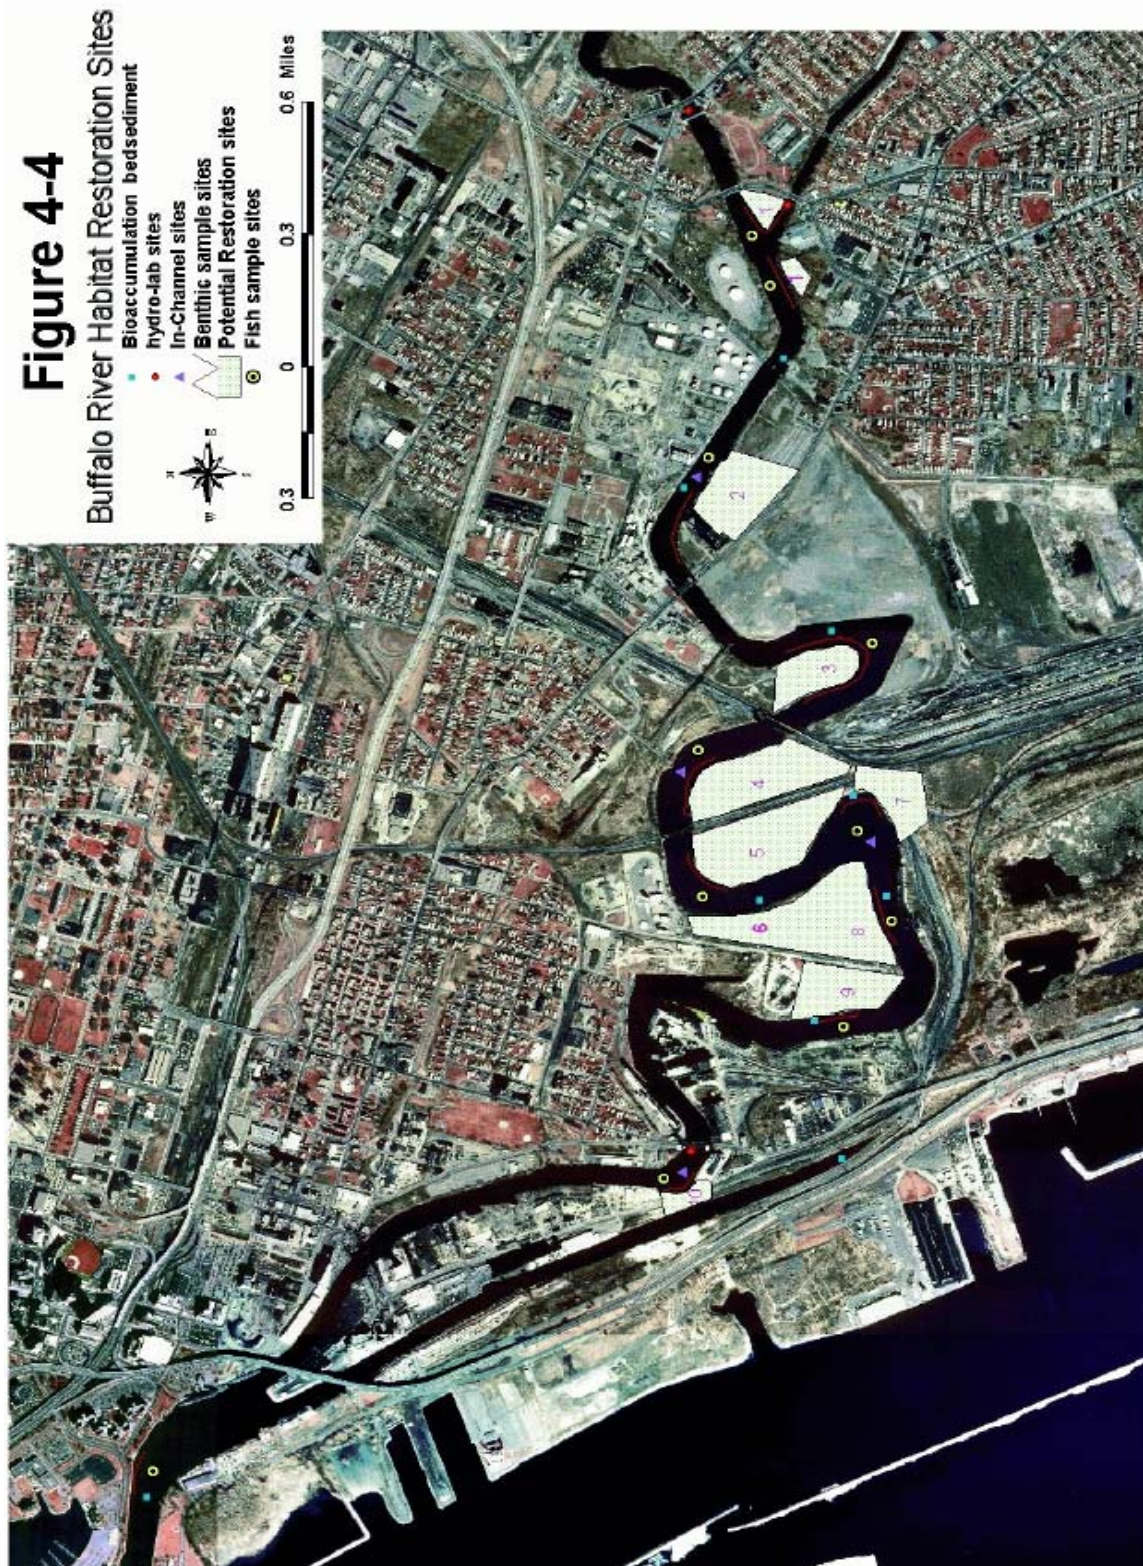
Five habitat restoration sites were identified; of which three “pocket parks” have been completed (Ohio Street boat launch, foot of Smith Street, Bailey Avenue peninsula); one is nearing completion (Seneca Bluffs); and one is targeted for future restoration (Katherine Street peninsula). (See Figure 4-3).

The Erie County Department of Environment and Planning (DEP) has completed Phase I of a natural habitat restoration effort in south Buffalo at a location known as “Seneca Bluffs.” Currently, funding is being sought for Phase II. Seneca Bluffs consists of 12.5 acres of floodplain located along the Buffalo River. Access to the site is near the Seneca Street Bridge, between Elk Street and Avon Place. (See Figure 4-3).

wildlife habitat restoration both upland and along the Buffalo River shoreline. The site is immediately adjacent to the Smith Street Habitat Restoration site (See Figure 4-3). The remediation included the removal of 44,000 cubic yards of contaminated sediment from the Buffalo River channel, placement of 42,000 tons of riprap for shoreline protection, nesting and feeding areas for waterfowl, the installation of nine “fish pods” in the river to allow for spawning and protection of fish and the planting of 3,800 pounds of special seed mixture to enhance wildlife habitat.¹⁵ NYSDEC conducts ongoing operations and maintenance activities as part of the grasslands restoration project.

Current NYSDEC restoration work at the Alltft site (See Figure 4-3) includes a wetlands project consisting of 12.5 acres of mixed wetland habitat, including shallow emergence, deep emergence and open water habitat. Plantings have been designed to enhance native non-invasive wildlife. The landfill has also been designed for future recreational opportunities. There is no official timetable for the site. Currently the property will remain vacant but will be maintained in accordance with the Department’s approved long-term operation and maintenance plan. Remediation activities are expected to be completed by the fall of 2005.¹⁶

The Times Beach Public Access Project is a collaborative effort, with the US Army Corps of Engineers conducting ecosystem restoration; Erie County, in cooperation with the City of Buffalo, providing public access; and the Times Beach Oversight Committee serving in an advisory capacity. Project highlights include elevated boardwalks, ground-level paths, bird watching blinds, overlook platforms and a bulletin-board style information kiosk. The Times Beach Project provides safe public access to one of the best birding areas in the Northeastern United States (see Figure 4-3 for location).
